NASA/TM-2001-210846

Structural Testing of a Stitched / Resin Film Infused Graphite-Epoxy Wing Box

*Dawn C. Jegley and Harold G. Bush
Langley Research Center, Hampton, Virginia*

April 2001

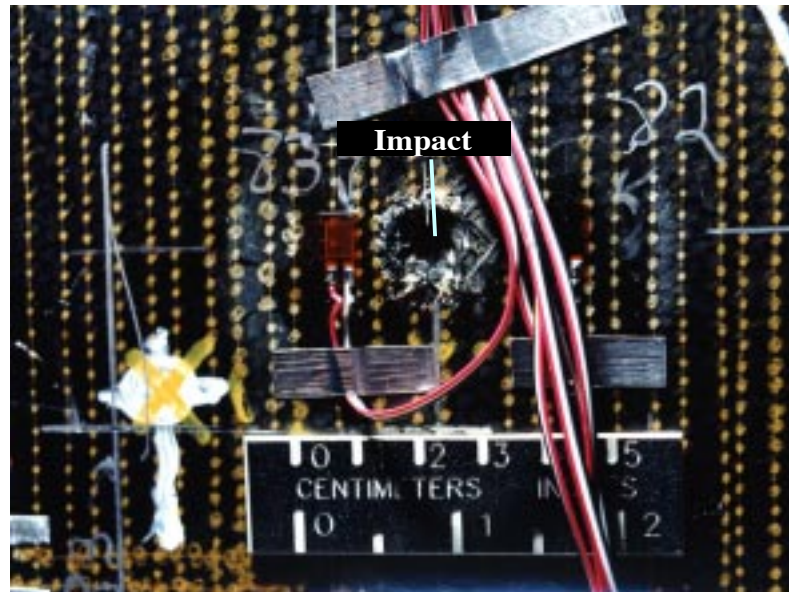
a) Site at rib 4

Figure 15. Lower cover impact damage locations.

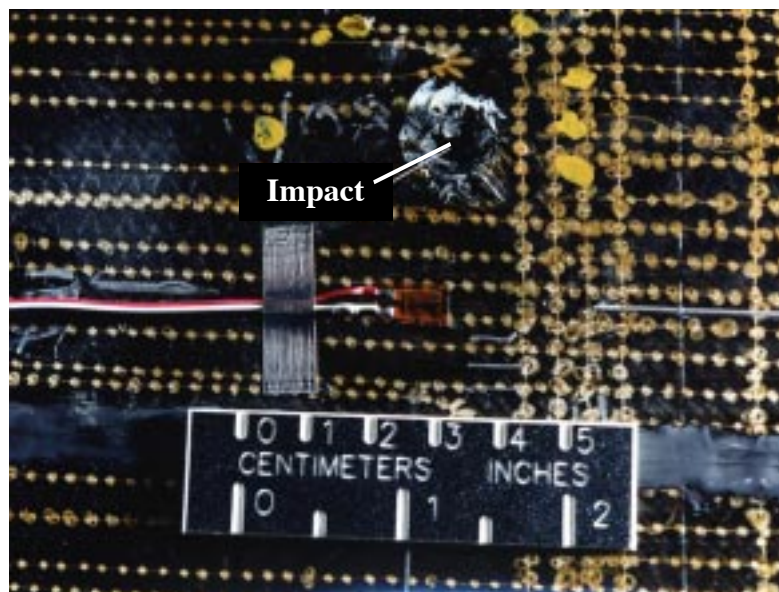
b) Site at rib 8

Figure 15. Continued.

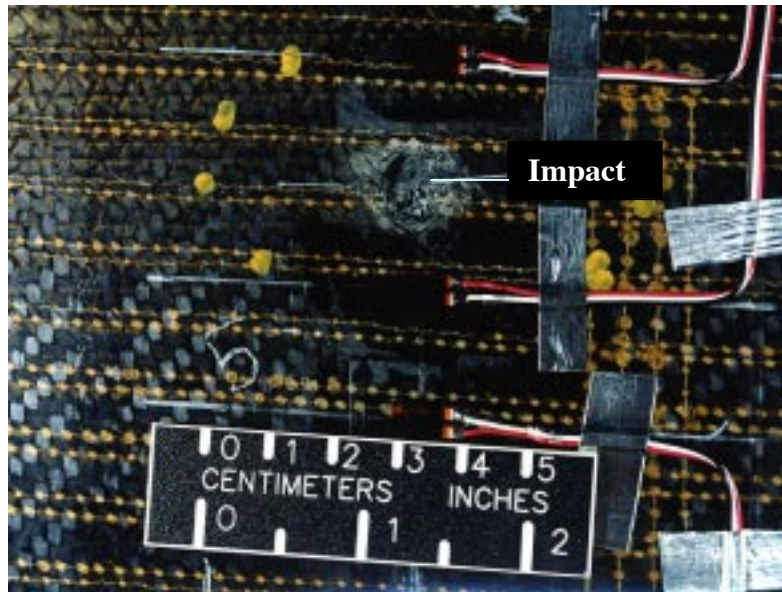
c) Site at rib 12
Figure 15. Concluded.

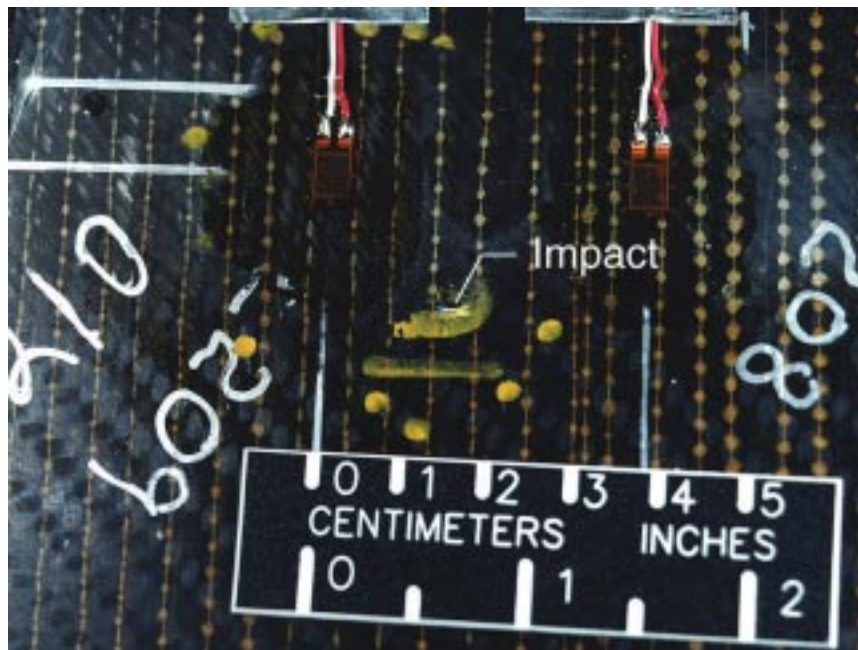
b) Site at rib 13
Figure 16. Concluded.

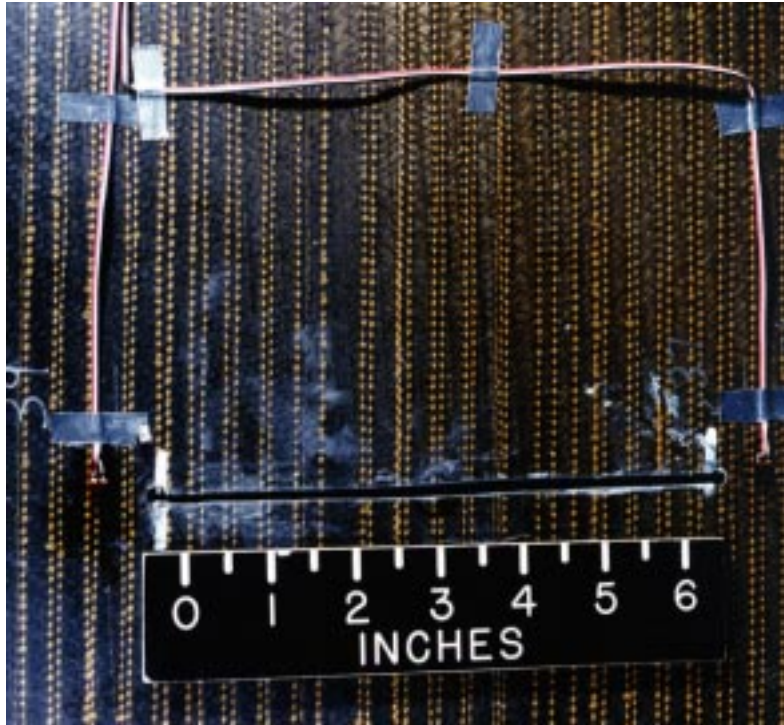
The effect of the sawcut on the behavior of the test article can be seen by comparing the strains measured in test 6 when the wing was loaded to DLL to the strains measured in test 7 in the presence of the sawcut. Axial strain gages were located on the internal and external skin at the sawcut tips and on the adjacent (uncut) stringers. These gage locations are shown in figure 12. Strain measured near the sawcut in the lower cover panel is shown in figure 62a and strains measured near the sawcut tips in the upper cover panel are shown in figure 62b. Internal strain is represented by solid lines and external strain is represented by dashed lines in the figures. Open symbols represent strain in the sawcut-damaged structure. Filled symbols represent strain in the undamaged structure. Strains at the sawcut tips are more than twice the strains at the same location in the undamaged structure. Strains remain linear for the full load range for the lower cover sawcut but sudden increases in strain occur in the upper cover panel sawcut tips internal surface. However, post-test ultrasonic inspection indicated no damage at the tips.

a) Lower cover panel
Figure 17. Sawcuts.

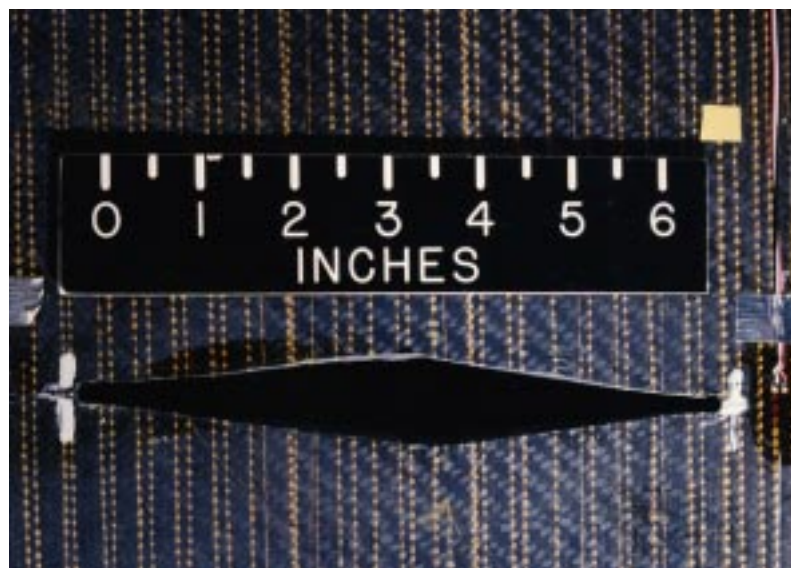
Strains in the upper cover panel between ribs 10 and 11 at stringers F, G and I, and at the front and rear spar caps are shown. Strain gage locations are shown in figure 8. Strains in the sawcut structure are 6 to 55 percent greater than in the undamaged structure. However, strains in the 70% DLL test remain less than 0.0025 in./in. The most significant increase in strain is in stringer G.

b) Upper cover panel
Figure 17. Concluded.

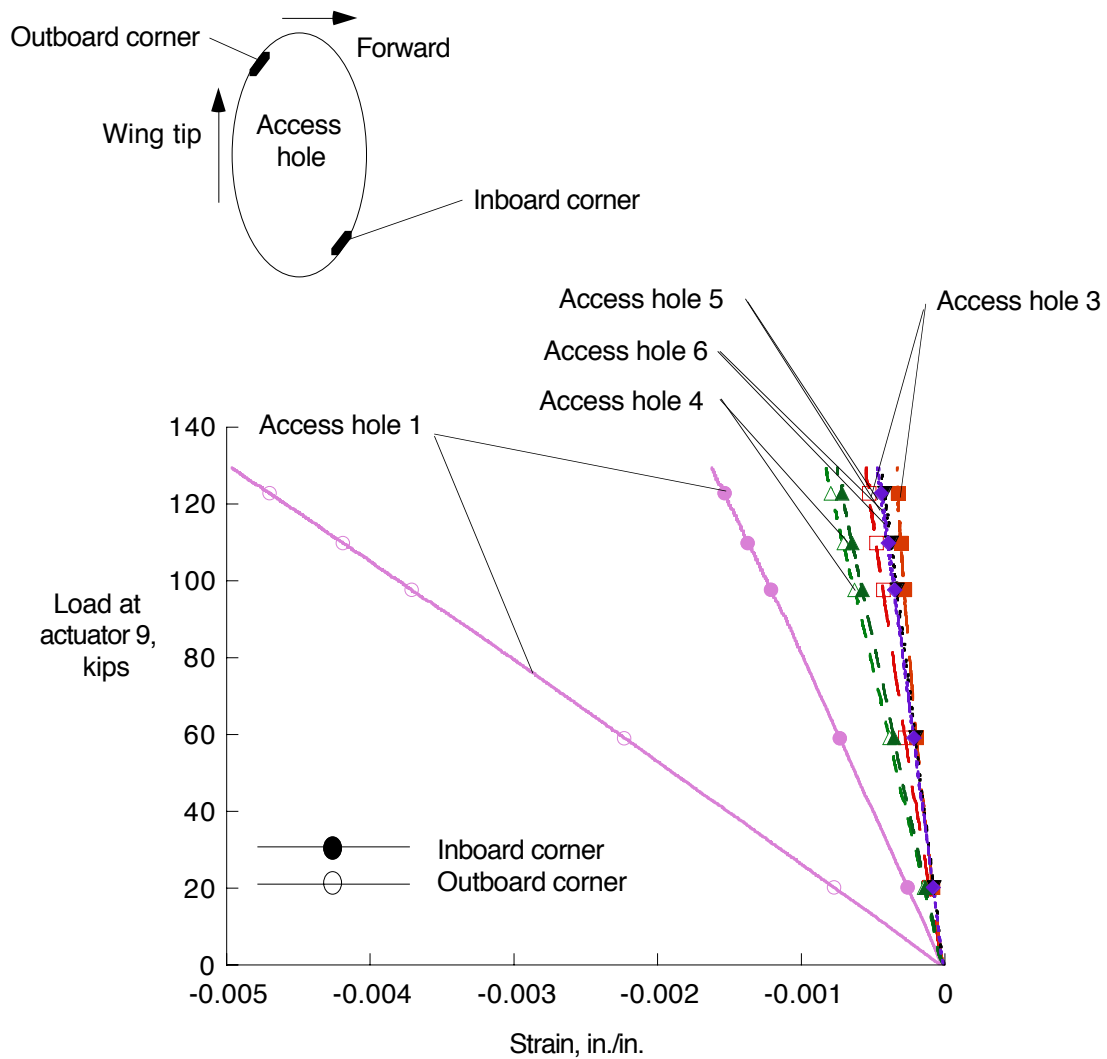
Figure 22. Measured strain at access hole edges for load to DLL in brake roll condition. Access hole locations are shown in figure 2.

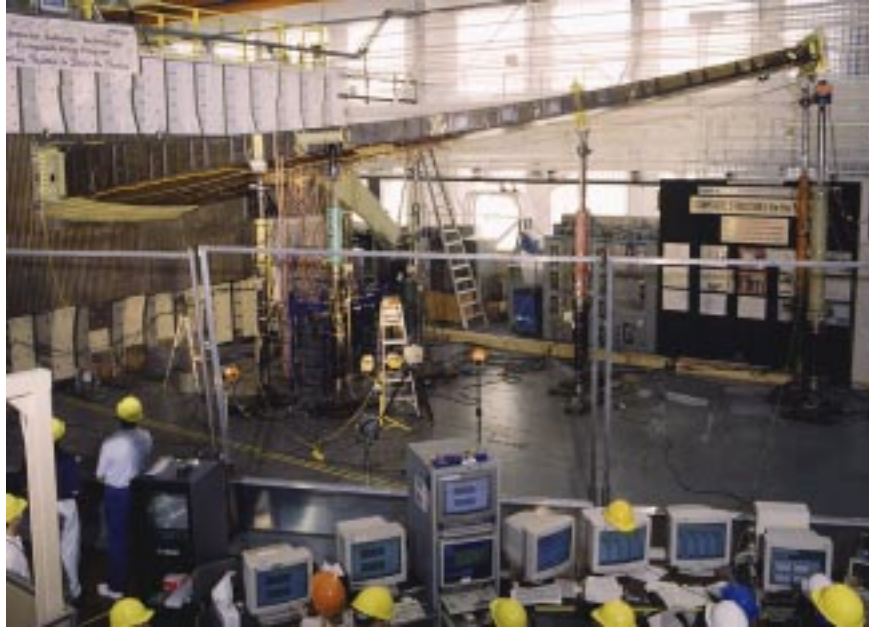
The test article supported 97% of its Design Ultimate Load (DUL) prior to failure. This load corresponds to the actuator load values shown in figure 46. A photograph of the test article loaded at 95% DUL is shown in figure 44. The primary failure location is across the lower cover panel through access hole 4. This region of the lower cover panel after final failure is shown in figure 75. The failure goes through all stringers but primarily remains between ribs 8 and 9. Both spars were also damaged, as shown in figures 76 and 77. Other minor damage was found but appears to be unrelated to the initial failure event. The discussion of the failure will be limited to the regions between ribs 6 and 10, the impact sites and the repairs.

Figure 44. Test article loaded to 95% DUL in 2.5G load condition.

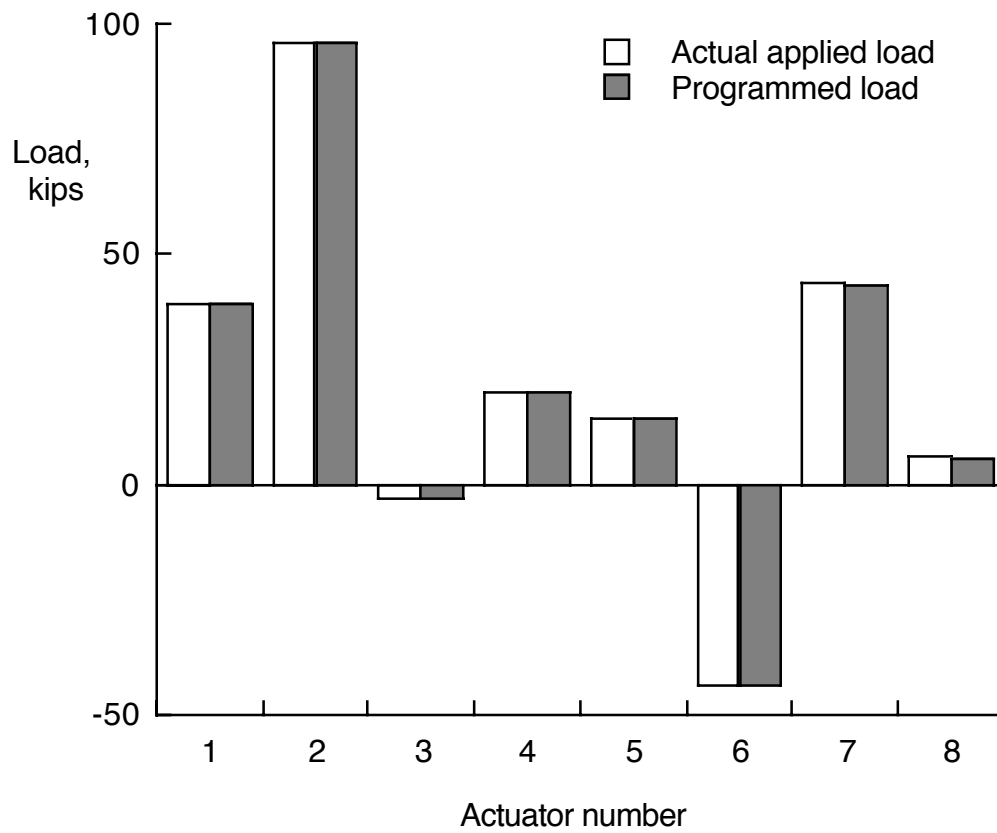
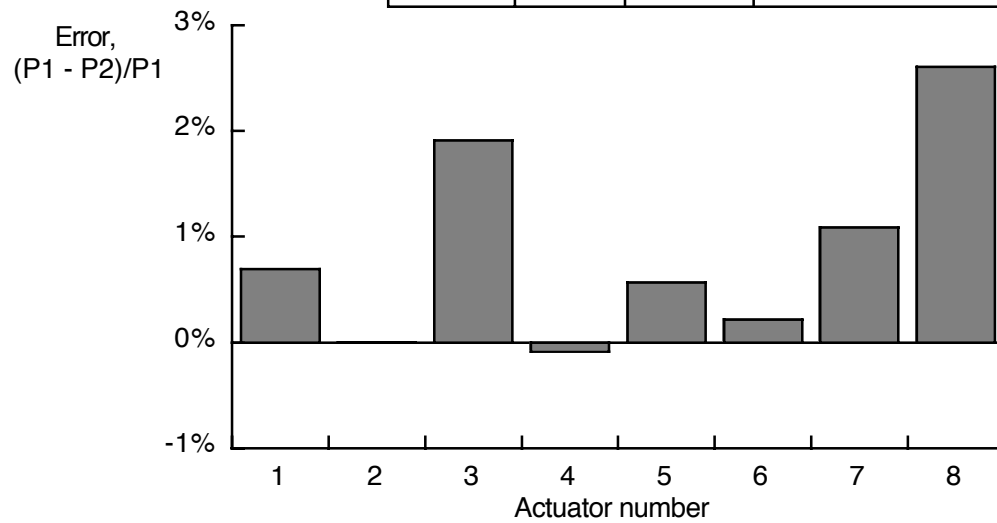
Figure 46. Loading in test to failure in the 2.5G loading condition.

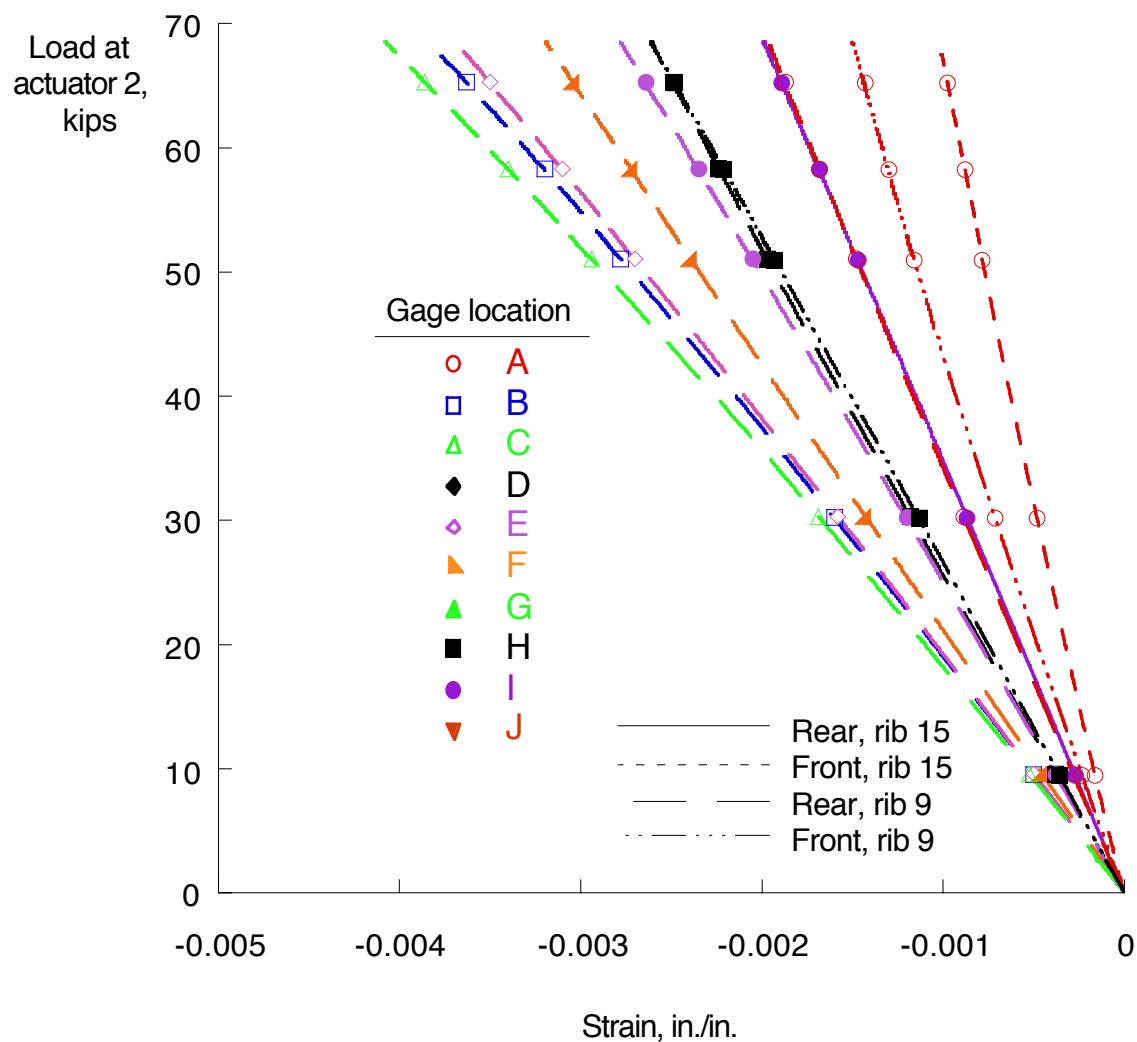
Measured strains at lower and upper cover runouts are shown in figures 52 and 53, respectively. These runouts are identified by the rib at which they terminate and their position front or aft. In the figure the length of the dashes is used to differentiate among runout locations. Symbols represent locations at the runouts. Open symbols represent strains on the interior surface of the test article. Filled symbols represent strains on the exterior surface of the test article. Strain gage locations are shown in figures 3 and 4. The lower cover is loaded in tension in this load condition, so all measured lower cover runout strains are positive. Similarly, the upper cover is loaded in compression in this loading condition, so all measured upper cover runout strains are negative. All runout strains are approximately linear except in the lower cover near the rear spar at rib 8. Strains do not exceed 0.004 in./in in magnitude except at that rear spar runout. At that runout location, gage E records a linear load-strain relationship up to approximately 0.004 in./in. strain, then it records significantly higher strain as load is increased, indicating some damage may have occurred at this location. However, post-test visual and ultrasonic evaluation could not identify any damage at this runout. Strain gage B at that runout displays a small discontinuity in the slope of the load-strain curve at a load of approximately 62 kips. The maximum strains in any upper cover runout location are in the runout at the rear spar at rib 9 as shown in figure 53.

Figure 53. Strain in upper cover stringer runouts for loading to DLL in the 2.5G load condition. Strain gage locations are shown on figures 3 and 4.

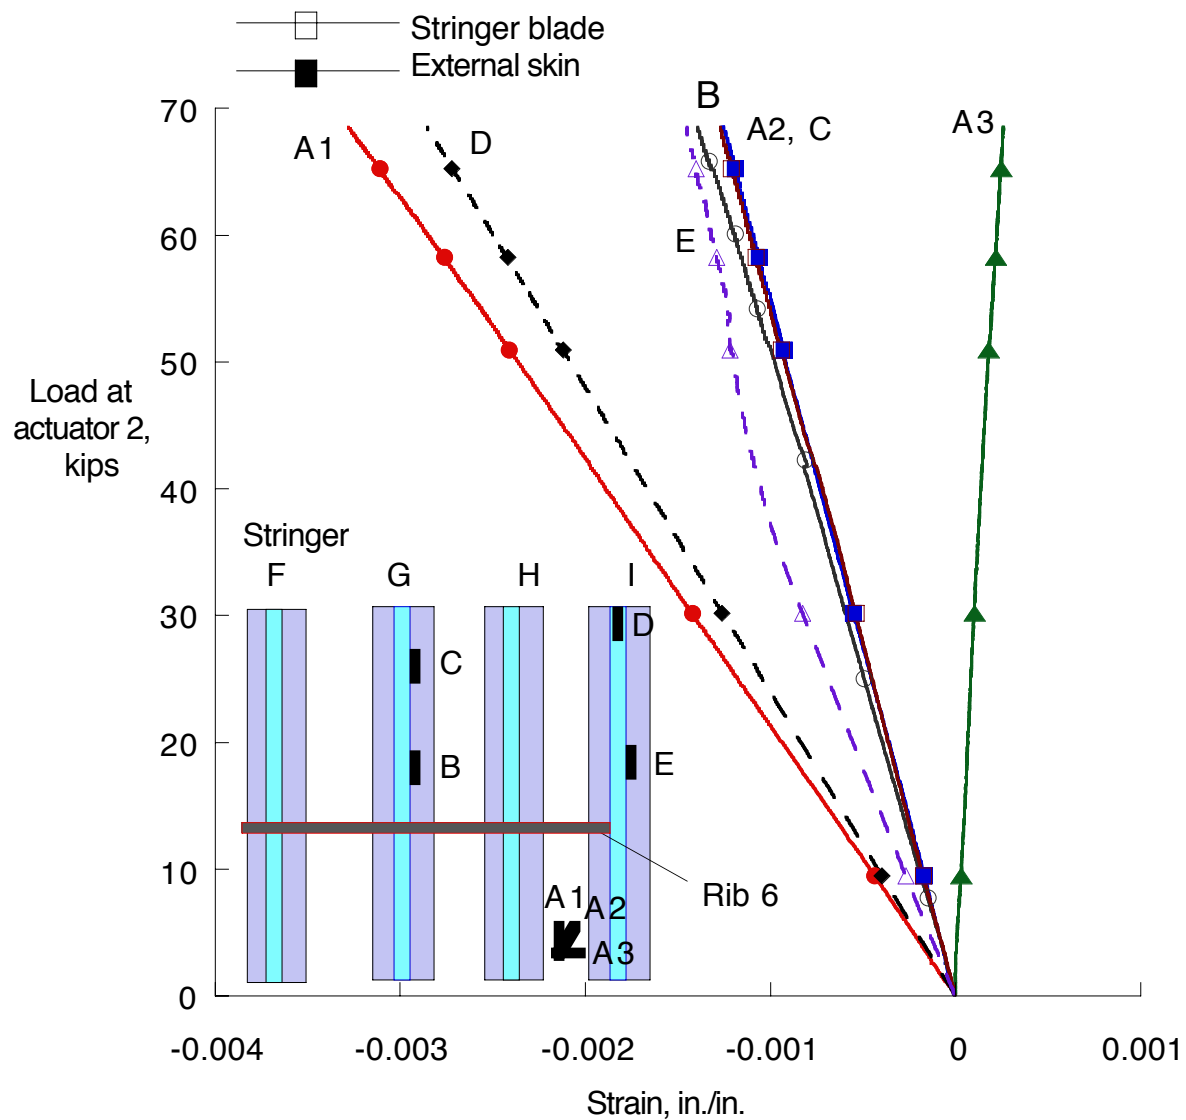
Measured strains in the main landing gear region are shown in figures 54-56. Strains in the upper and lower cover panels are shown in figures 54 and 55, respectively. Strains in the main landing gear doublers are shown in figure 56. Strain gage locations are shown in figure 9. All measured strains in the upper cover MLG region are linear except at stringer I. None of these strain values exceed 0.0035 in./in. The strain measured at stringer I shows discontinuities in slope at the load-strain curve for loading greater than approximately 50 kips. Strains at the lower cover intercostal at rib 5 show a discontinuity in the load-strain curve at a load of approximately 45 kips, as shown in figure 55. Strain in stringer I at rib 6 is linear for load less than about 65 kips, then decreases instantaneously. Several strains in the MLG doublers display nonlinear behavior. Strains near the edges of the upper and lower cover doublers are nonlinear and show discontinuities in the slope of the load-strain curve.

Figure 54. Strain in upper cover main landing gear region for loading to DLL in the 2.5G load condition.

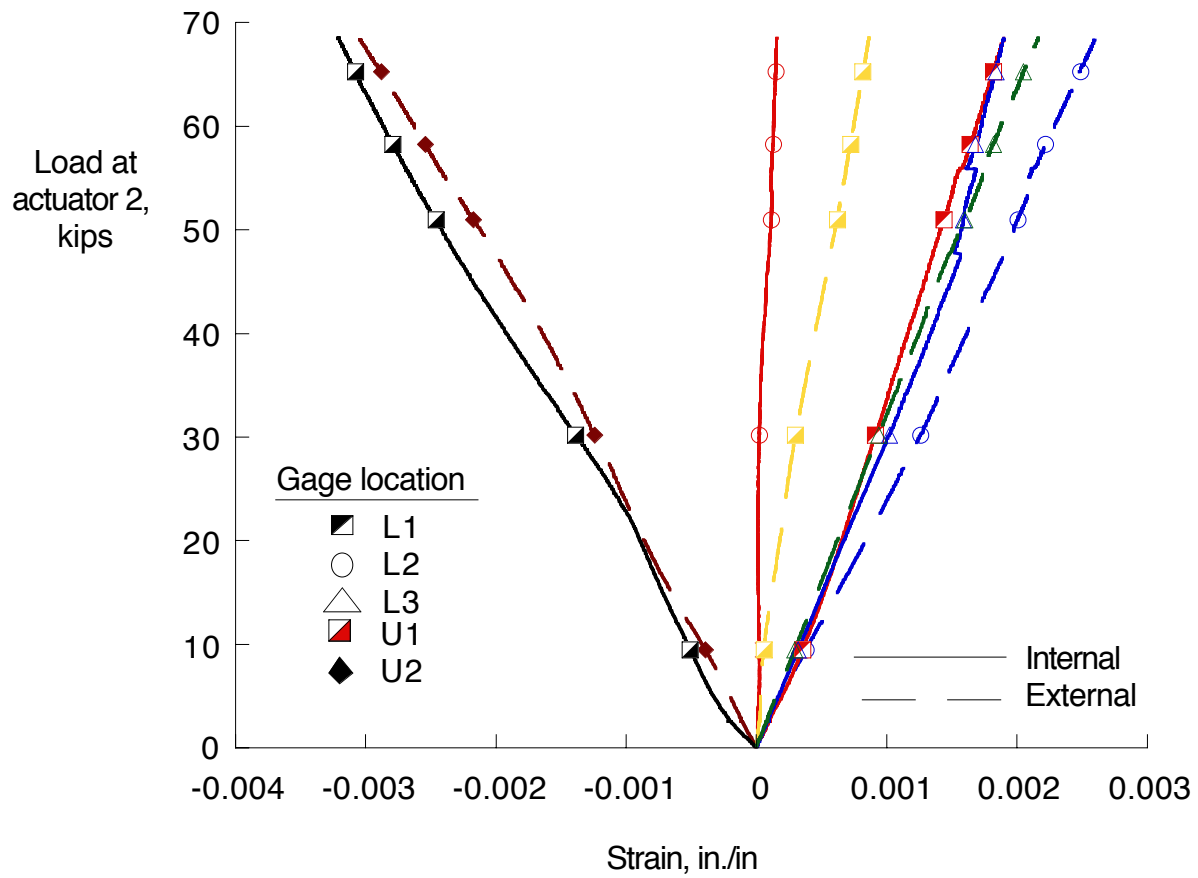
Measured strains in the upper and lower cover splice between the root transition box and the composite box are shown in figure 57. Strain gage locations are shown in figures 7 and 8. Open symbols represent lower cover panel strains, filled symbols represent strains on upper cover panel and half-filled symbols represent strains on the root transition box. All measured strains in the root splice region of the cover panels are approximately linear with increasing load except at location U2 where the load-strain curve is nonlinear. No strain exceeds 0.0035 in./in. in magnitude.

Figure 57. Strain in root region at DLL for 2.5G load condition. Strain gage locations are shown in figure 7 and 8.

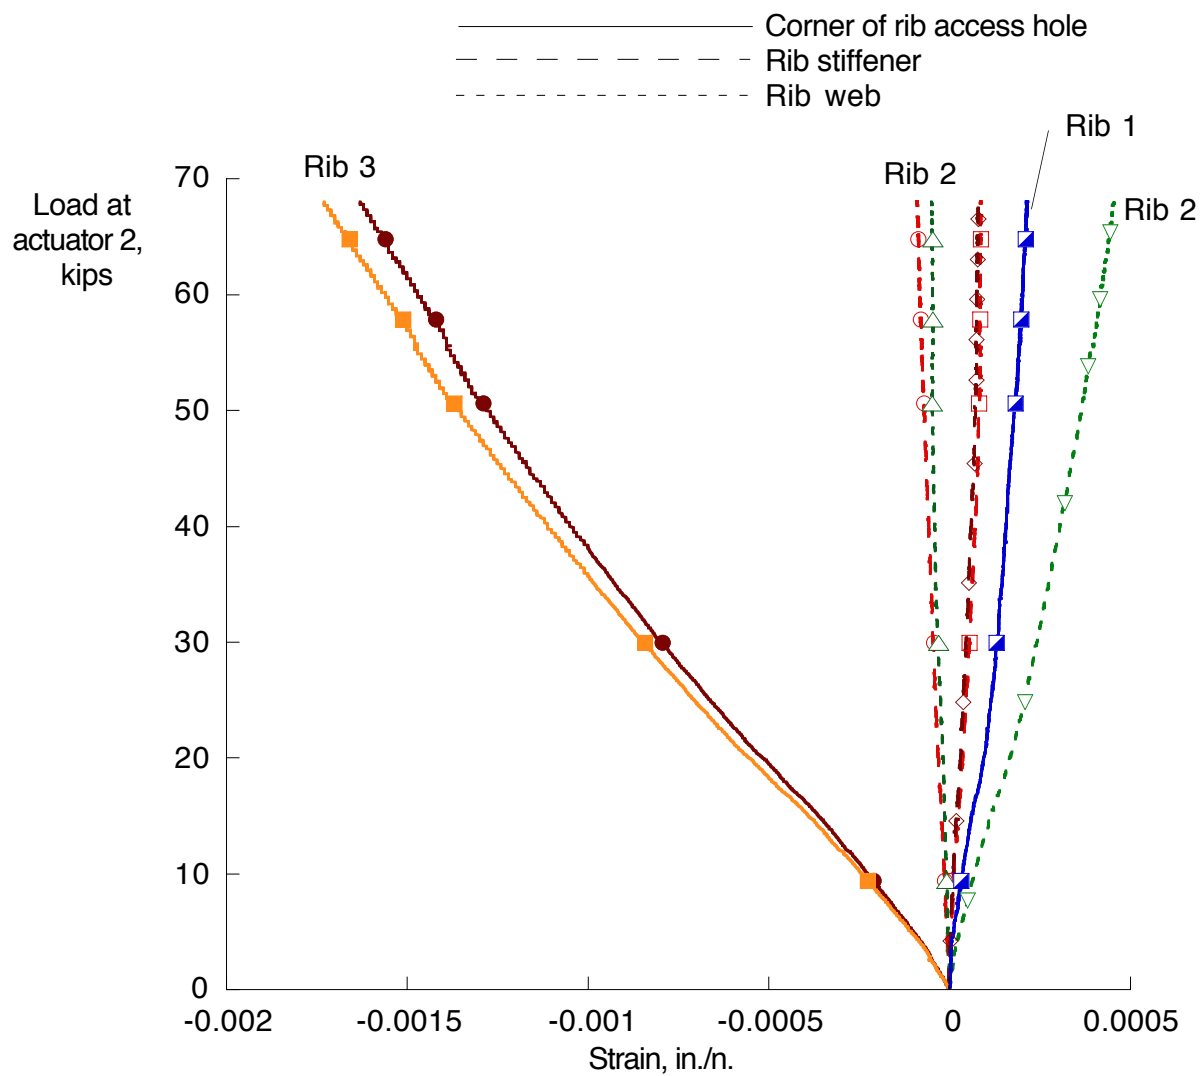
Measured strains in all ribs are less than 0.002 in./in. in magnitude. However, strains in ribs 2 through 15 display nonlinear behavior. Measured strain in ribs 2 and 3 are shown in figure 58. Measured strains in ribs 4, 5 and 6 are shown in figure 59. Measured strains in ribs 7, 8 and 9 are shown in figure 60 and are typical of ribs 10 through 15. Strain gage locations for ribs are shown in figure 11. For each figure, gage location is distinguished by line type and symbol. Even though strains are small, back-to-back strain gages show separation from the onset of loading, indicating the ribs are bending locally at the access hole in ribs 3 and 4 and globally in ribs 6-15. No back-to-back gages were placed on the rib away from the access hole in ribs 4 or 5 which could be used to determine if this bending behavior is restricted to the hole region.

Figure 58. Measured strain in ribs 1, 2 and 3 for loading up to DLL for the 2.5G load condition. Strain gage locations are shown in figures 11a, 11b, and 11c.

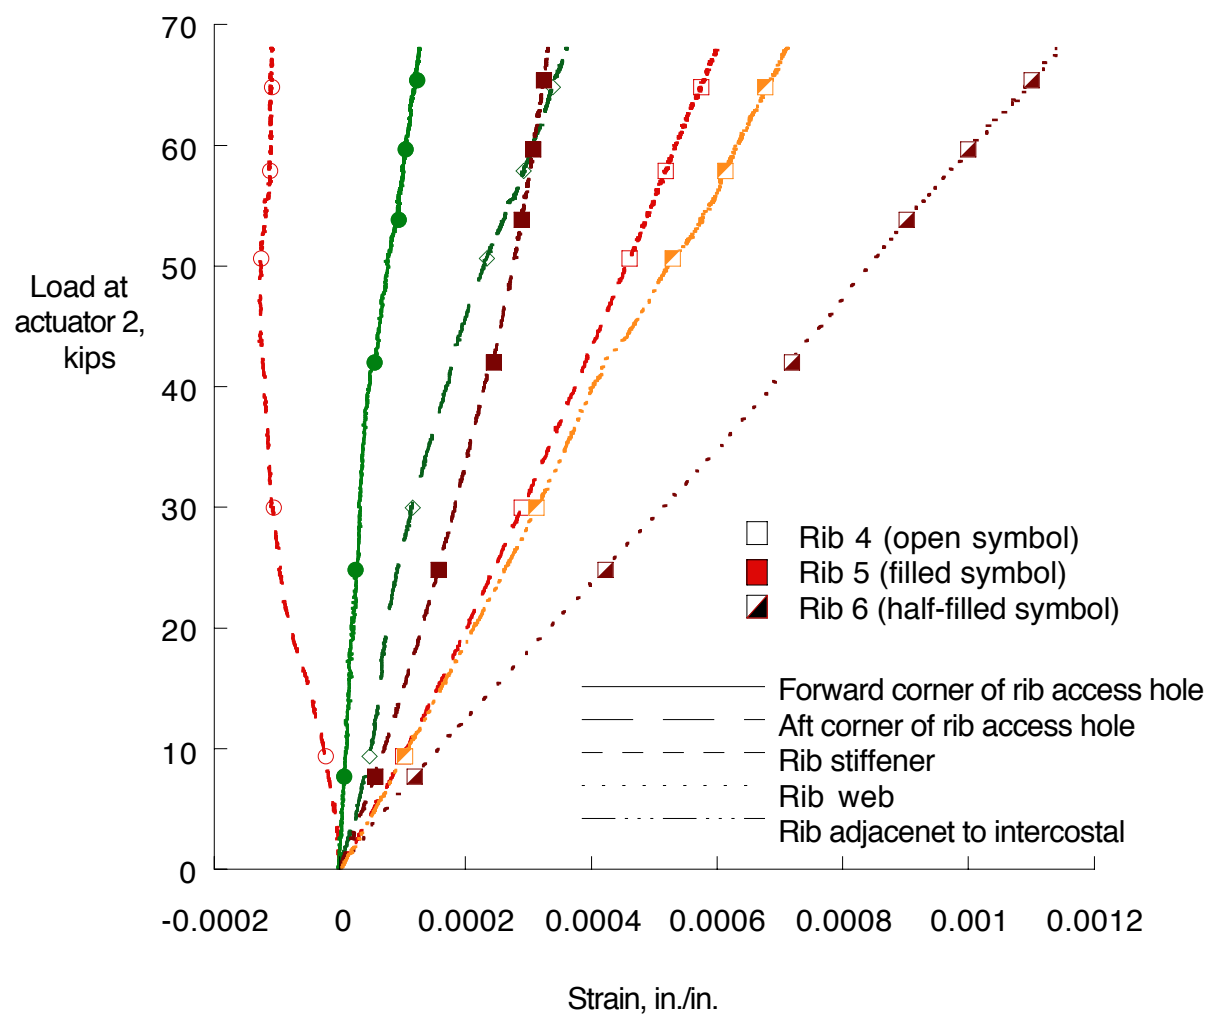
Figure 59. Strain in ribs 4, 5 and 6 for loading to DLL in the 2.5G load condition. Strain gage locations are shown in figure 11d and 11e.

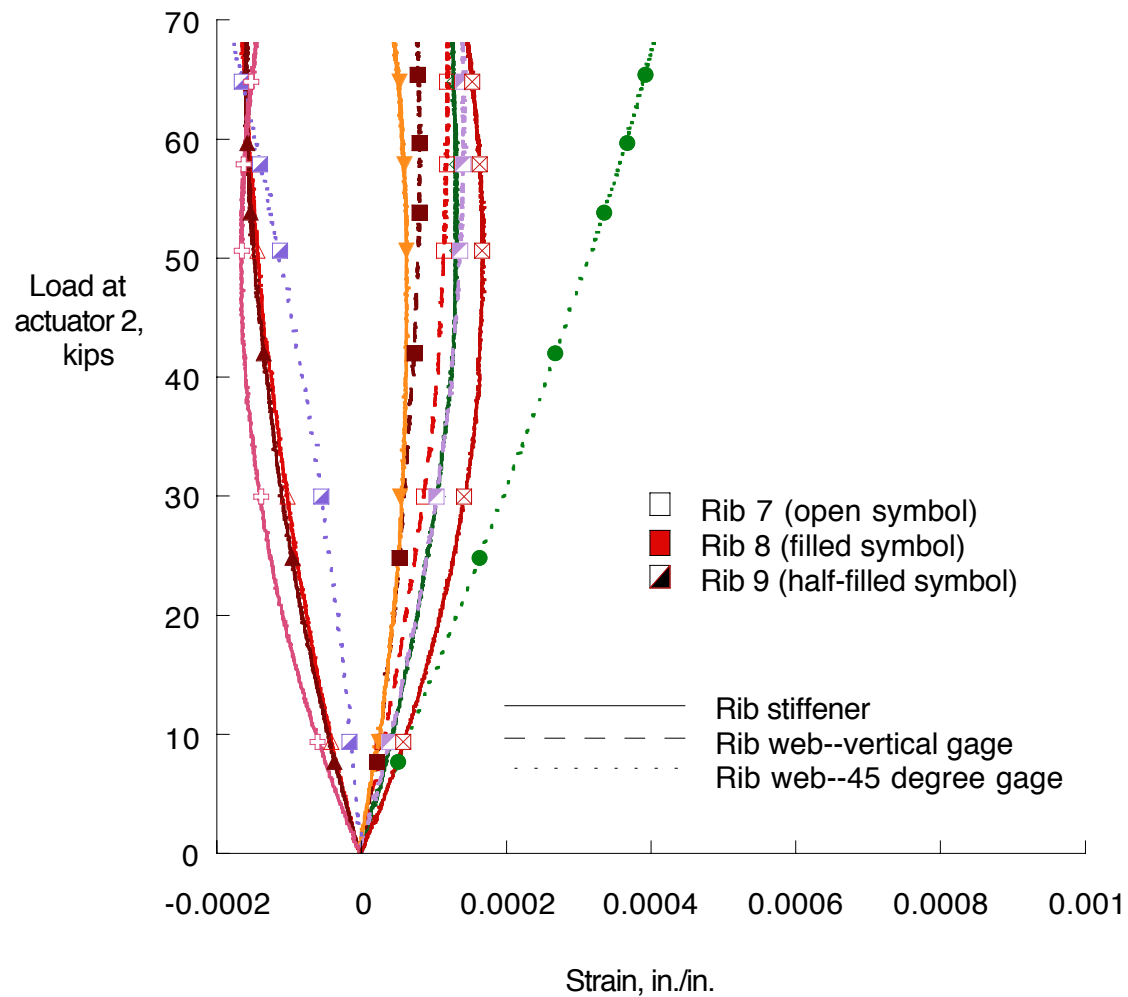
Figure 60. Strain in ribs 7, 8, and 9 for loading to DLL in the 2.5G load condition. Strain gage locations are shown in figure 11f.

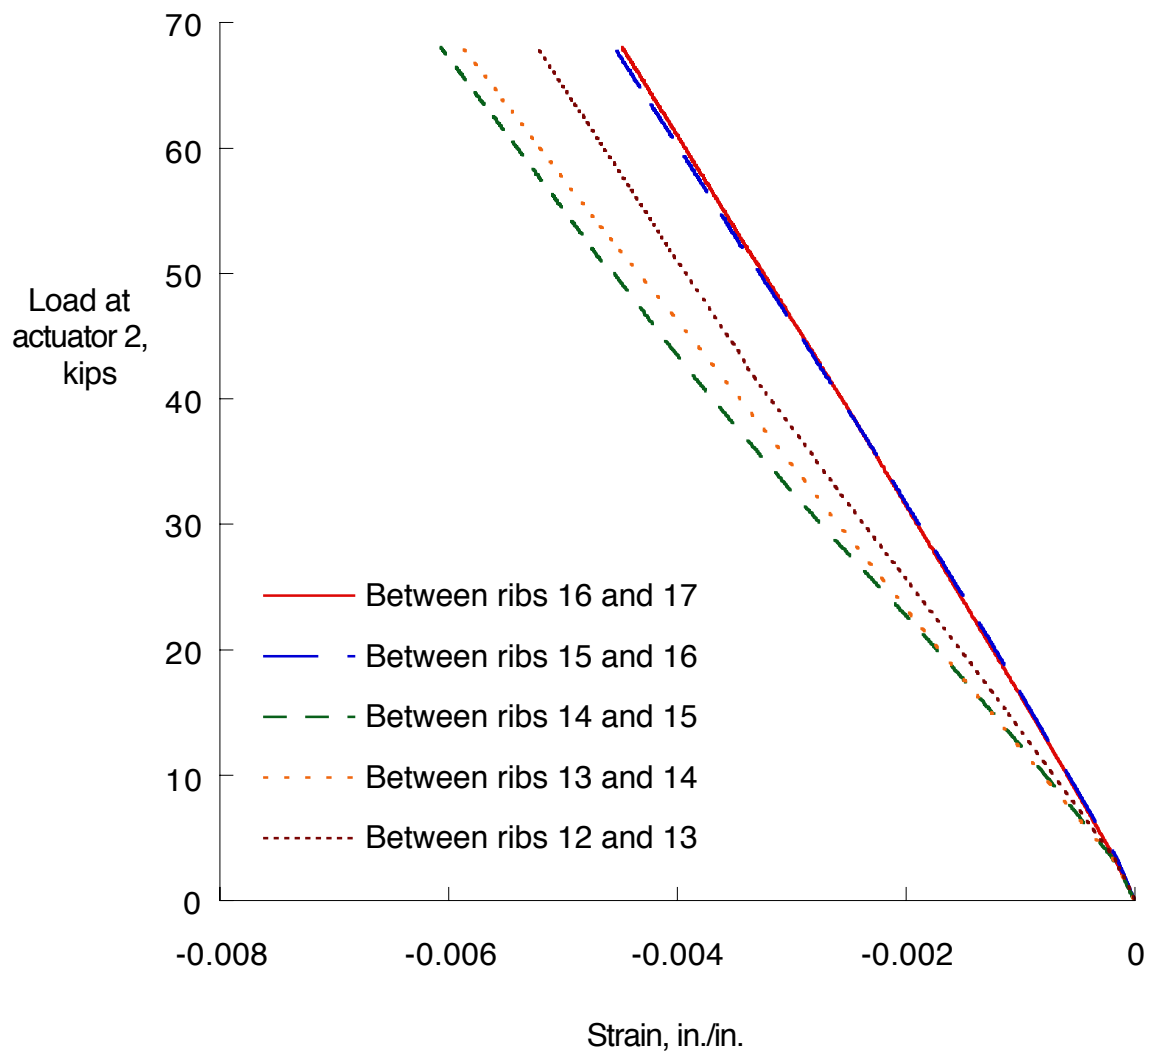
Measured strains in the front and rear spars are linear and with maximum values between -0.008 and 0.004 in./in. Strains measured in the front spar are shown in figure 61.

Figure 61. Strain in front spar for loading to DLL in the 2.5G load condition.

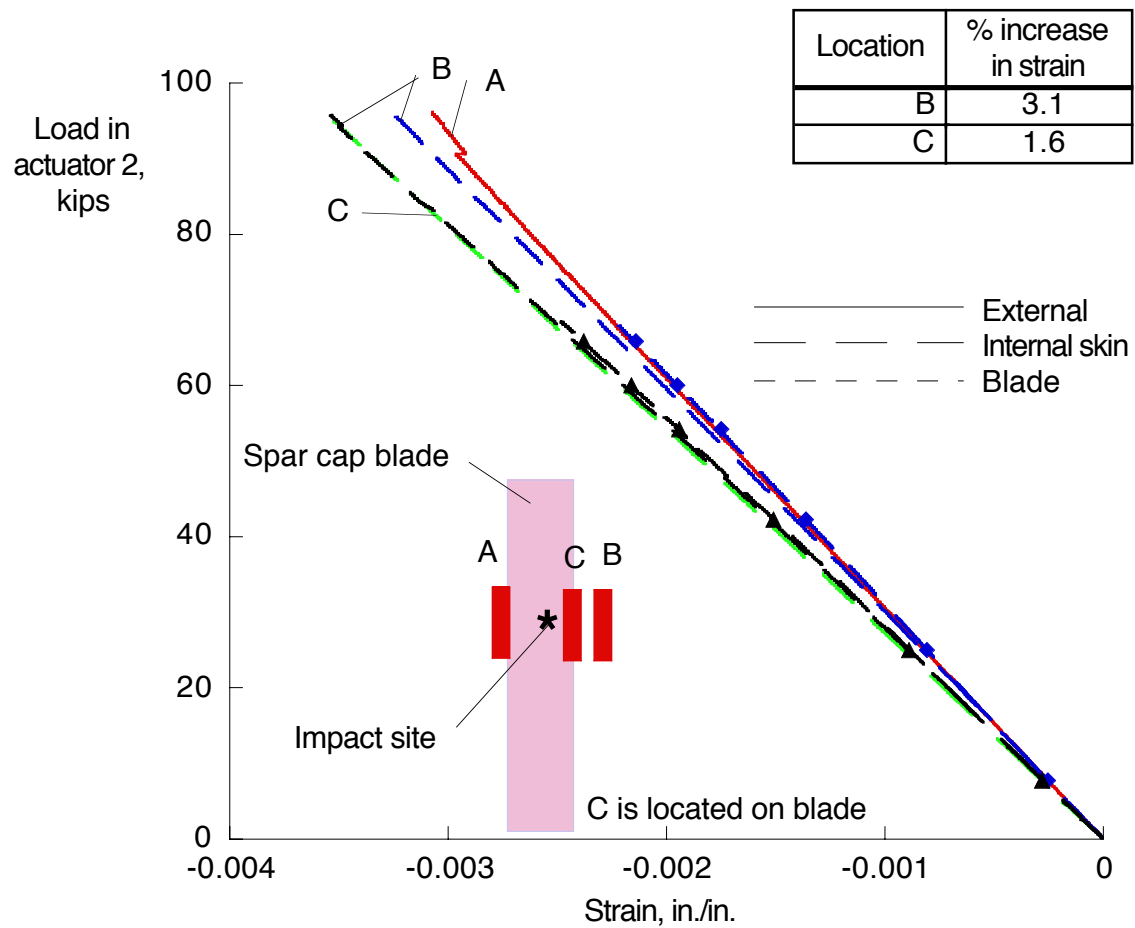
Strains in the upper cover panel at impacts at rib 4, at rib 9 and at rib 13 are shown in figures 68, 69 and 70, respectively. Internal skin strains are represented by long dashed lines and external skin strains are represented by solid lines. Blade strains are represented by short dashed lines. The lines with filled symbols represent strain of the undamaged structures. The lines with no symbols represent strain in the damaged structure. Strains at the rib 13 impact and the rib 4 impact remain linear as load is increased. At the load values corresponding to DLL, the strain increases at these two locations by no more than 4% due to the presence of the impact and strain does not exceed 0.005 in./in. in magnitude. The percentage increase in strain at each location is show on the figures.

Figure 68. Effect of impact damage on strain at upper cover rear spar cap near rib 4. Gage and impact locations are shown in figure 13c.

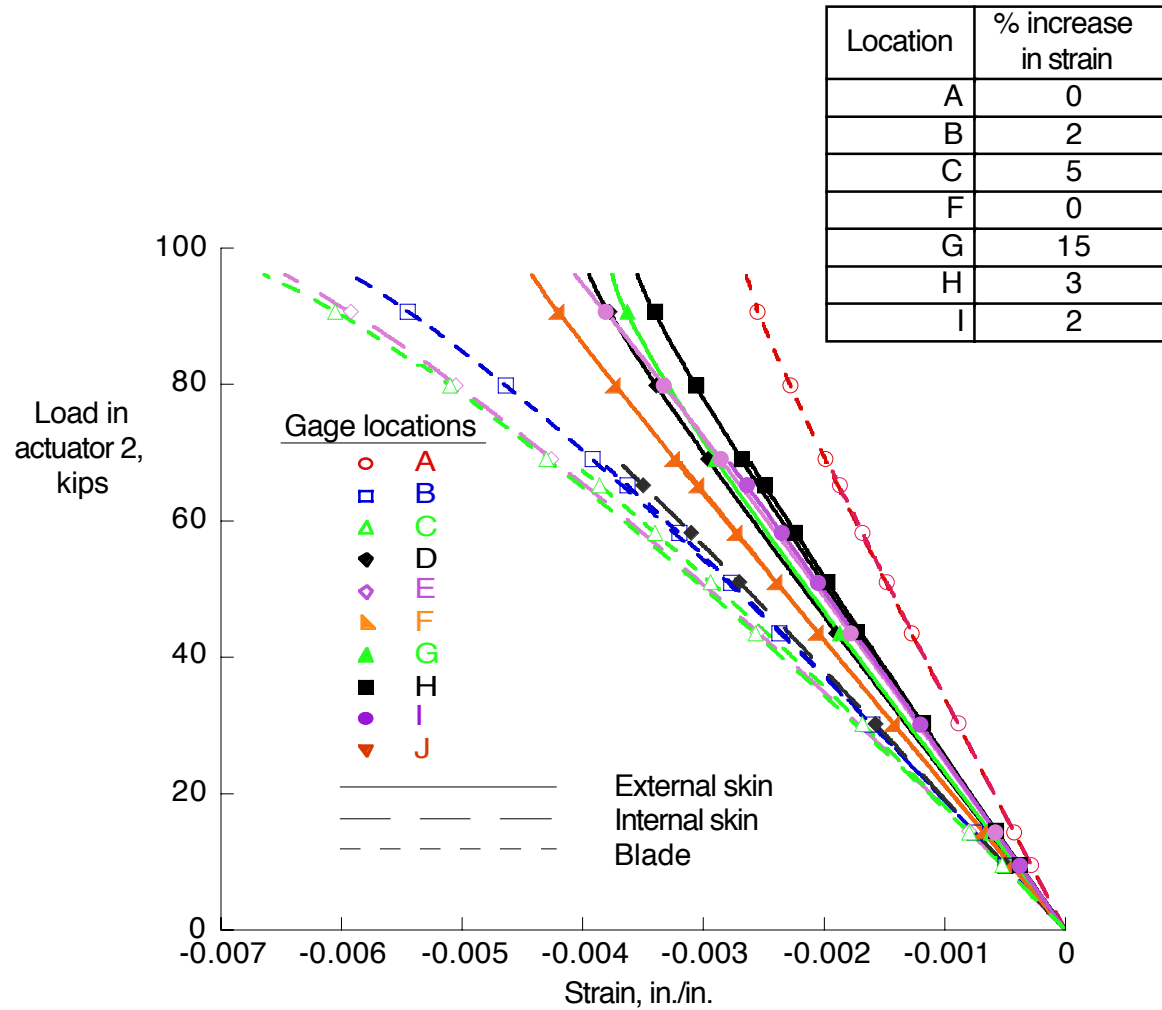
The impact site at rib 9 is at the location that stringer J terminates. Long dashes represent the strain on the internal skin surface and short dashes represent the strain in the stringer blade. This region was more heavily strain gaged than others to capture strain gradients due to the presence of the runout. Strain gage locations are show in figure 3. Strain gages on the stringer blade record an increase in strain of up to 5%. The most significant increase in strain is near the termination point of the blade, location G in figure 69

Figure 69. Effect of impact damage on strains at upper cover stringer runout at rib 9. Strain gage locations are shown on figure 3.

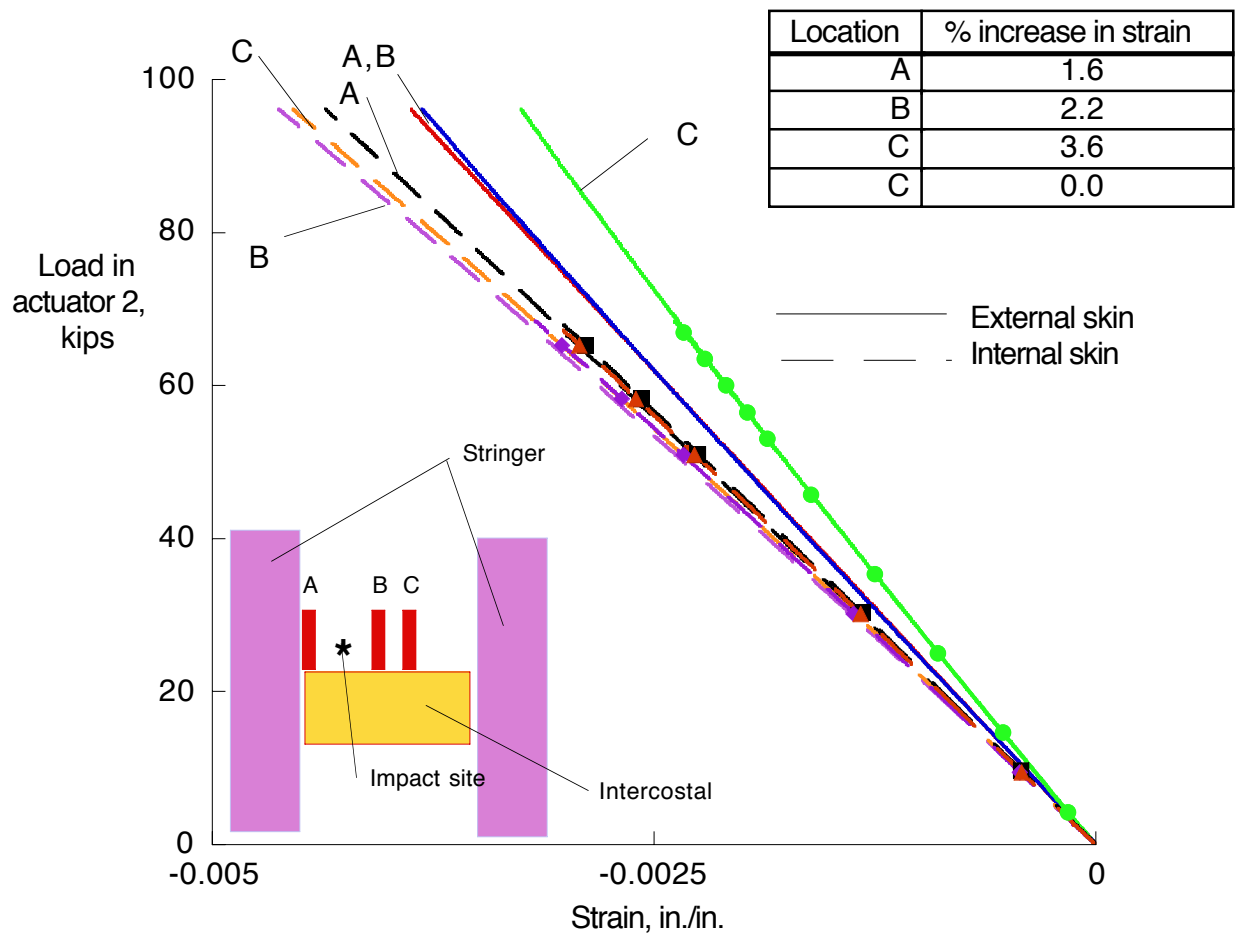
Figure 70. Effect of impact damage on strains in upper cover panel skin adjacent to rib 13. Strain gage locations and impact site are shown in figure 13a.

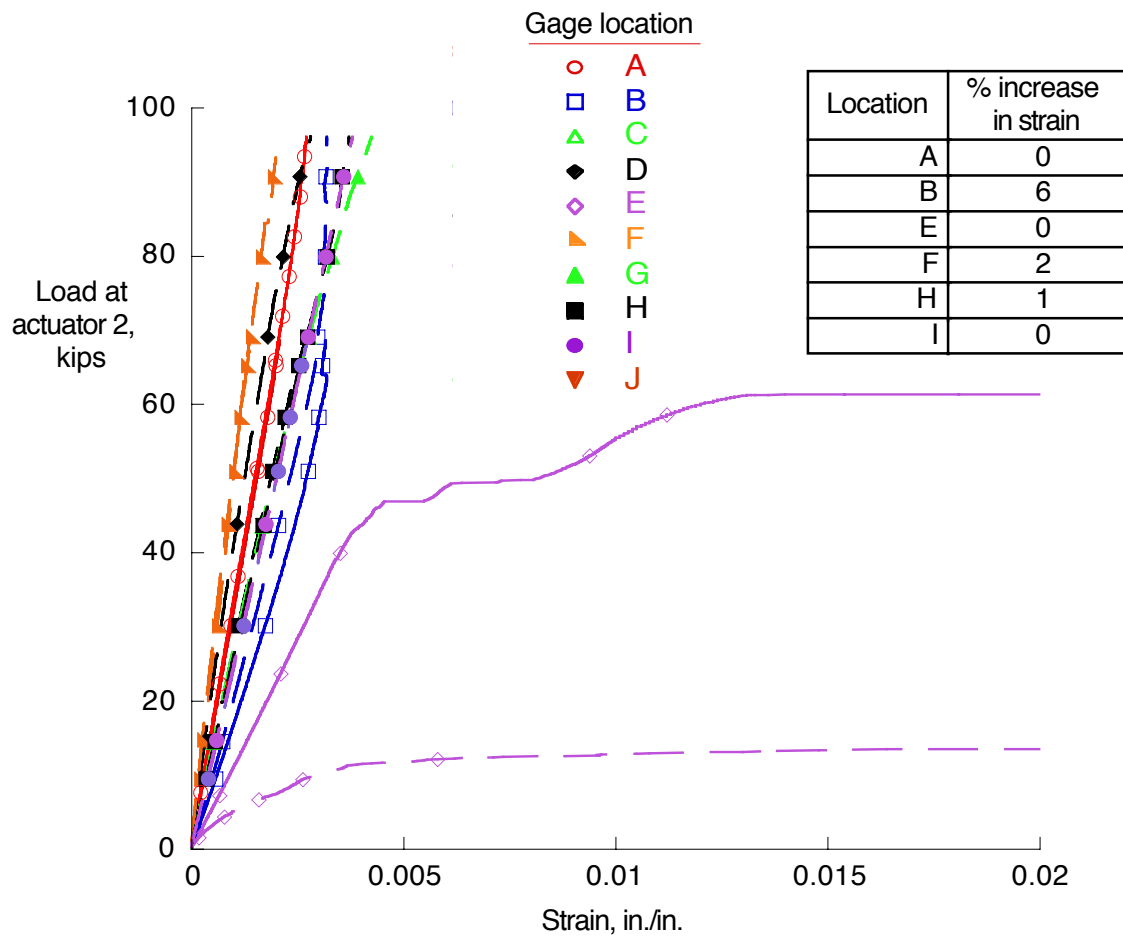
Figure 72. Effect of impact damage on strains at lower cover stringer runout at rib 8. Strain gage locations are shown on figure 3.

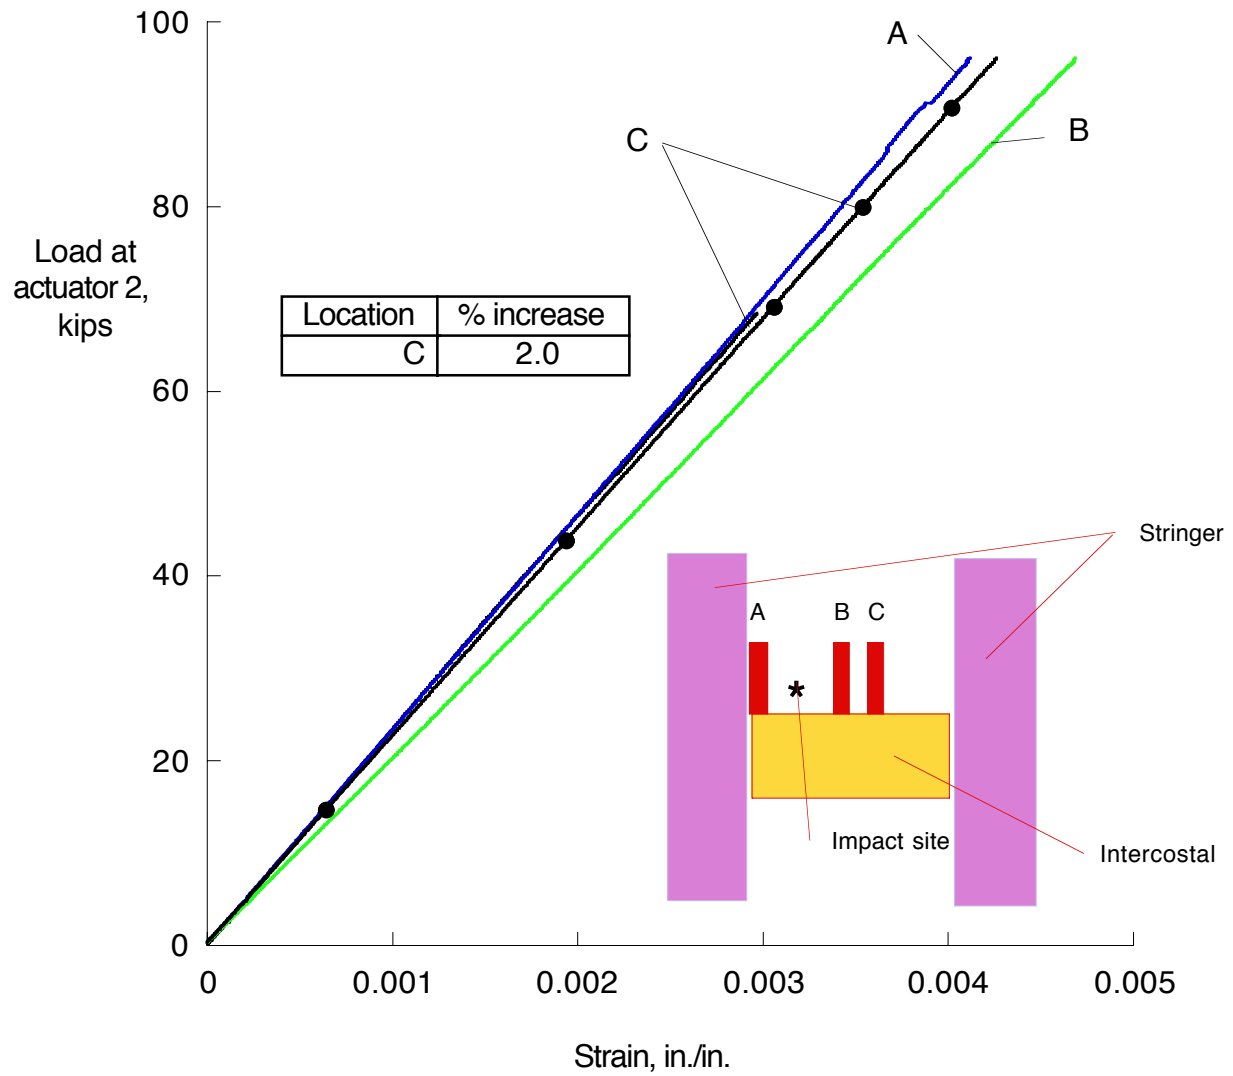
Figure 73. Effect of impact damage on strain in lower cover panel skin adjacent to rib 12. Strain gage and impact locations are shown on figure 13a.
